Damage to Roadway Infrastructure from 2016 Central Italy Earthquake Sequence

Maria Giovanna Durante,^{a)} M.EERI, Luigi Di Sarno,^{b)}
Paolo Zimmaro,^{c)} M.EERI, and Jonathan P. Stewart,^{c)} M.EERI

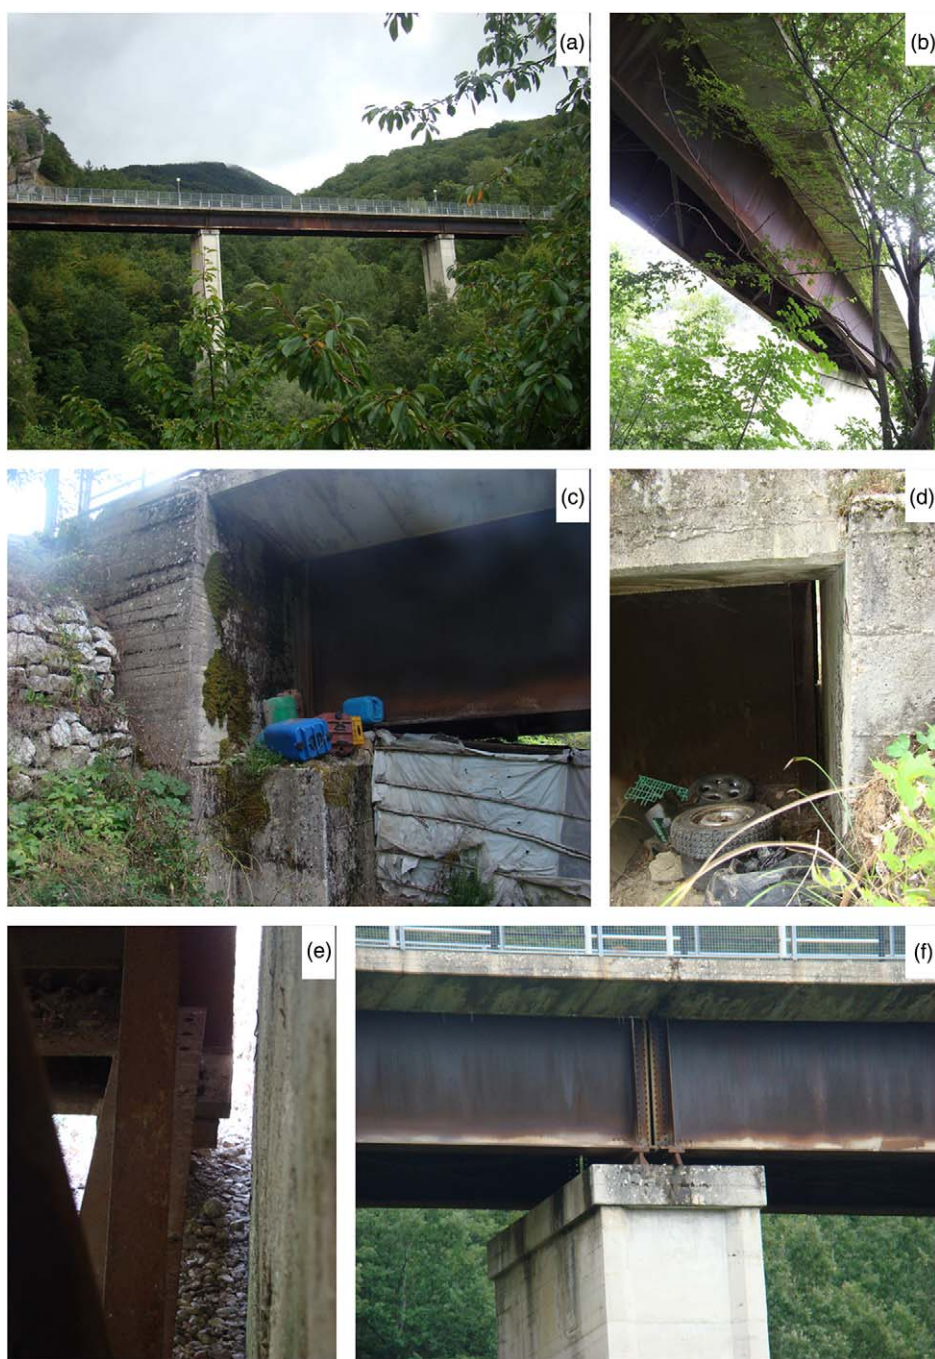
As shown in Table 1, the bridge likely to have experienced the largest ground shaking was the composite steel and concrete bridge along the Strada Provinciale (SP) 20 Colle (km 9+650), also called *Ponte Ramazzotti* (Figure 3). *Ponte Ramazzotti* (C1 in Figures 1 and 2) is formed by three composite steel and concrete spans, two RC piers, and two abutments. The bridge experienced some movements during the 24 August 2016 event (Figure 3). The movements have been accommodated by the bridge deck and did not affect the road surface or the structural components and, for this reason, limits on bridge utilization were not required.

Figure 3. *Ponte Ramazzotti*: Composite steel and concrete bridge along the SP20 in Colle (42.7276 deg, 13.3111 deg). (a, b) overview of the bridge, (c) abutment, and (d, e, f) bridge support details.

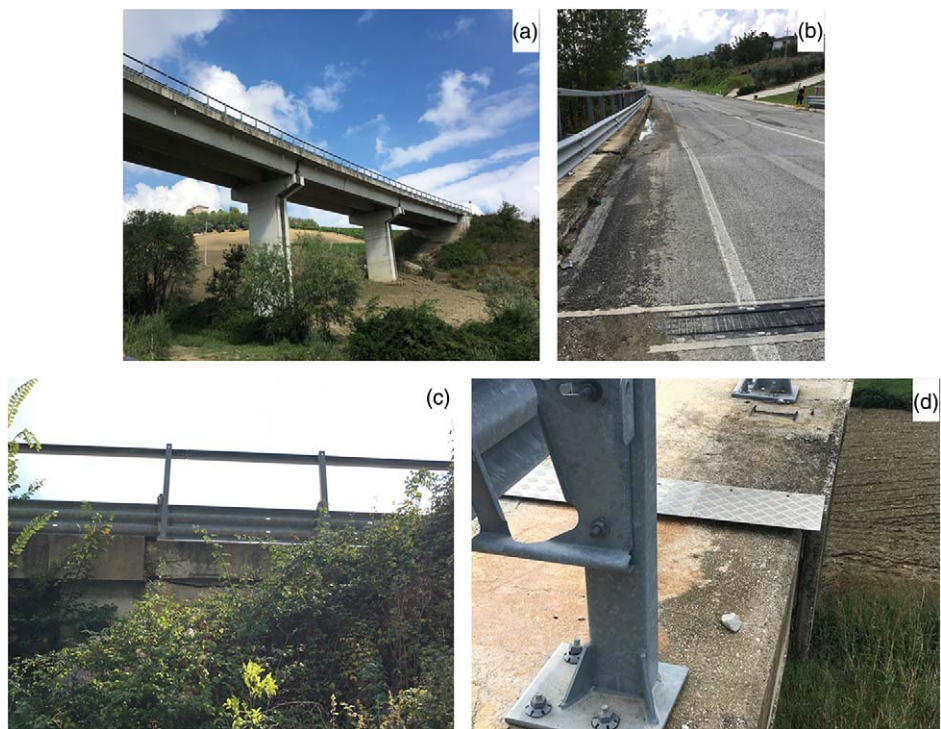
Another interesting bridge that was inspected is the RC bridge along the SP173 in Offida (Figure 4). This bridge (R1 in Figures 1 and 2) had significant settlement of the roadway close to the abutments (Figure 4b), which caused damage at the structural elements (Figure 4c). These settlements, which existed before the earthquake, appear to have been exacerbated by seismic compression of backfill during the 24 August 2016 main shock. Thus it was suggested to limit the maximum load to be carried by the bridge until specific geotechnical improvements to stabilize the area could be performed.

Figure 4. RC bridge along the SP173 in Offida (42.9417 deg, 13.7023 deg): (a) Overview of the bridge; (b) settlement of the road; (c) crack; and (d) relative displacement of the abutment.

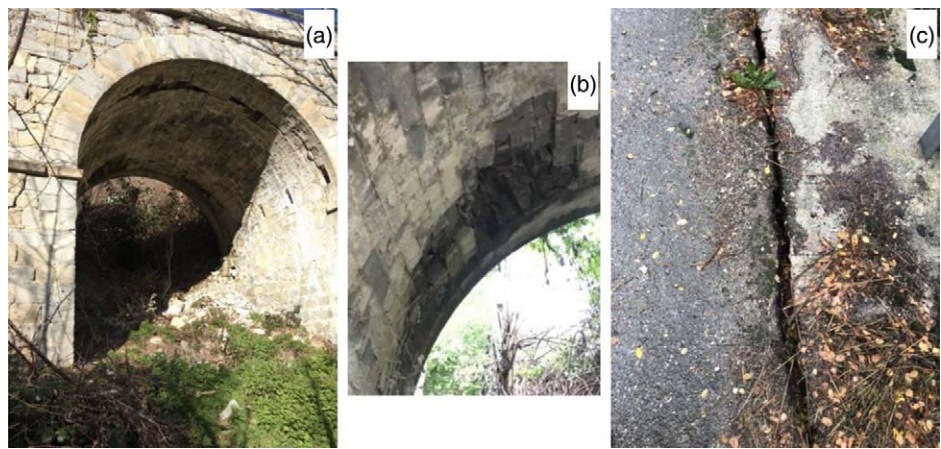
In the first inspection, a one-span masonry bridge along the Trisungo route near Tufo (M3 in Figures 1 and 2) presented cracking within load-bearing masonry elements within the arch

Figure 5. Roman-era bridge along the Trisungo route (1 span bridge, Tufo area, Arquata del Tronto: 42.7360 deg, 13.2549 deg): (a) View of the arch following the October event; (b) spalling of the interior of the arch; and (c) road cracks after the 24 August event, which grew slightly during the October event

(Figure 5a), including spalling (Figure 5b). Cracking adjacent to the roadway surface was observed immediately behind the wall, which increased slightly between the first and second inspections. Otherwise, the damage at this location were not appreciably different at the times of the two inspections.

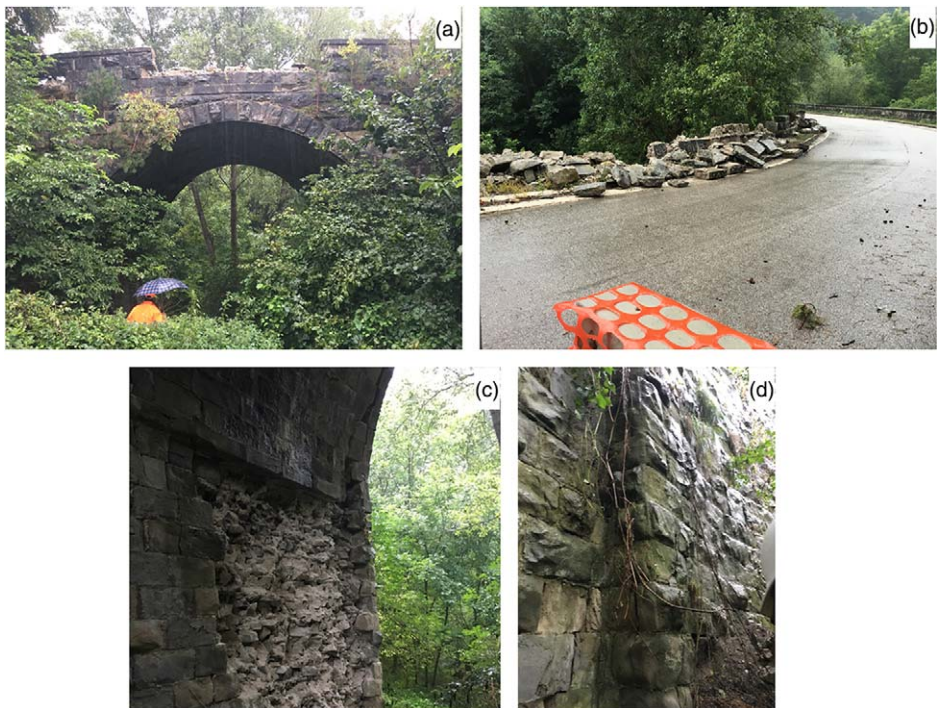
In the first inspection, the three-span bridge (M4 in Figures 1 and 2, hereafter Tufo bridge) presented partial collapse of short walls above the roadway surface (Figure 6a and 6b), spalling of several elements in the central arch (Figure 6c), and significant cracks of some masonry elements on the east support of the central arch (Figure 6d). This damage occurred in relatively recently added sections of the bridge. The older Roman-era portions of the bridge did not exhibit obvious signs of damage.

Figure 6. Central arch of the Roman-era three arches masonry bridge along the Trisungo route (42.7354 deg, 13.2537 deg) as observed following the August 2016 event: (a, b) Partial collapse of the railing; (c) spalling; and (d) cracking of some masonry elements in the central arch.

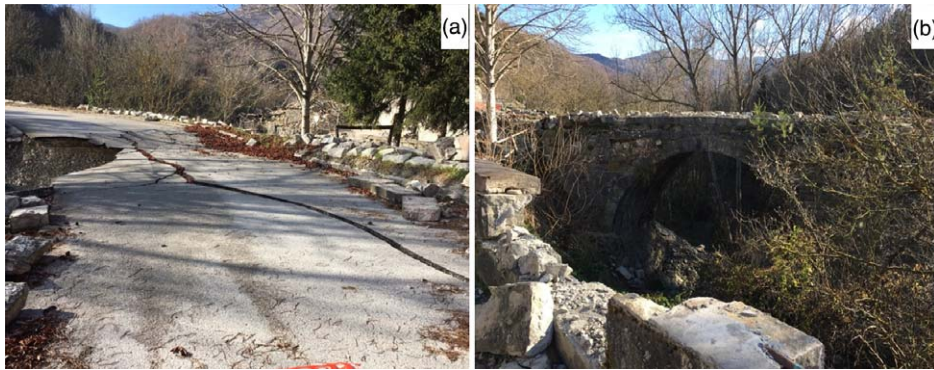
The Tufo bridge was inspected again in December 2016 after the October 2016 sequence. Significant additional damage was observed (Figure 7). In particular, part of the central arch, already damaged after the first event, collapsed as a result of the October earthquakes. Figure 7a shows large longitudinal cracks on the roadway surface (not present following the 24 August earthquake). The masonry rail, which was damaged during the 24 August event (shown in Figure 6a and 6b), totally collapsed following the October events (Figure 7b).

Figure 7. Three-arches bridge along the Trisungo route (same location as in Figure 6) after the 30 October 2016 event (photos taken on 13 December 2016). (a) Large longitudinal cracks on the roadway surface (same location as Figure 6b); and (b) total collapse of the masonry rail (same location as Figure 6a). The collapse of the arch is not visible in the pictures.

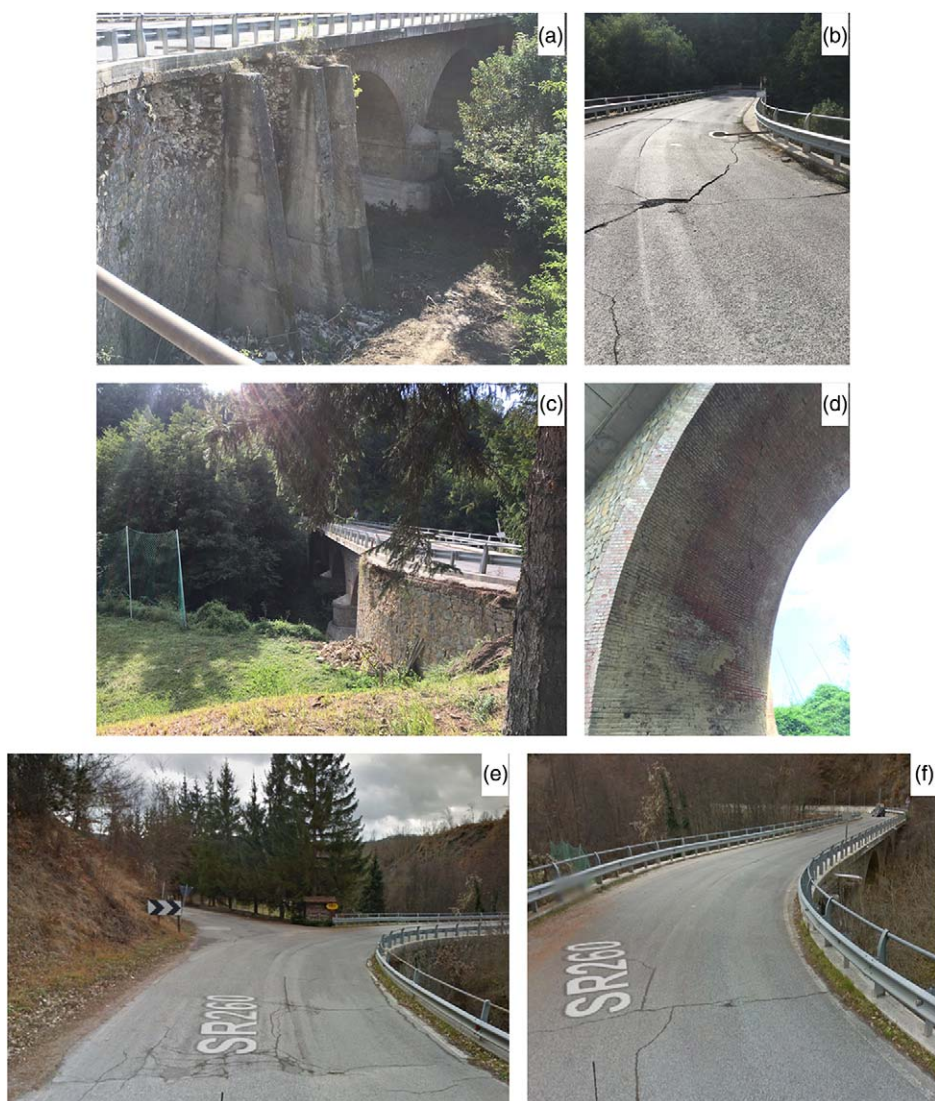
The masonry bridge referred to locally as the *Ponte a Tre Occhi* in Amatrice (M1 in Figures 1 and 2) was inspected following the 24 August and 30 October earthquakes. This bridge crosses the Castellano River and represents a critical lifeline for access to Amatrice, and it was closed on the date of our first visit (8 September 2016). The bridge is formed by three arches and the main structure is composed of *muratura a sacco*, which is a typical method of masonry construction (Giuliani 1993). This method consists of using regular-shaped masonry elements on the external part of the construction, sometimes with between-element mortar. The interior part of the construction is composed of relatively irregularly-shaped cobbles, usually without mortar. During the 24 August 2016 earthquake, several sections of the external (regular-shaped) layer collapsed (Figure 8a and 8c). This resulted in a lack of confinement of the interior uncemented cobbles, which then underwent lateral relaxation and settlement that was observable on the roadway surface (Figure 8b). These diffuse transverse cracks along the road surface had maximum openings of about 5 cm and 2.7 cm horizontally and vertically, respectively. Some deformation of the road surface was evident before the main shock, as shown in Figure 8e and 8f (dated December 2011). Moreover, internal cracking was observed on all the arches of the bridge (Figure 8d).

Figure 8. *Ponte a Tre Occhi*: Masonry bridge along the SR260 in Amatrice (42.6207 deg, 13.2902 deg). (a, c) Abutment deformations on two sides of the bridge, (b) road settlement, (d) cracks on the arch, (e) pre-event cracks along the SR260, and (f) bridge–abutment connection [source for (e, f): Google Maps (<https://www.google.com/maps/>; last accessed 13 September 2018)].

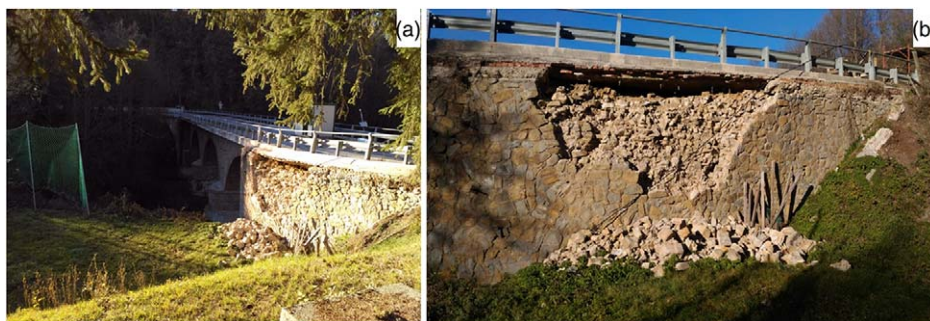
As a result of the October events, the *Ponte a Tre Occhi* experienced additional damage, consisting mainly of spalling of outer layer masonry elements located along abutment areas (not involving the three arches; Figure 9a and 9b). At the time of the reconnaissance (2 December 2016), repairs had been carried out on one of the two abutments, while the bridge masonry and structure appeared to have not yet been repaired.

Figure 9. *Ponte a Tre Occhi* (same location as in Figure 8) after the 30 October 2016 event (photos taken of 13 December 2016): (a) Damage to abutment in same section shown in Figure 8c; and (b) closer view of masonry collapse along abutment.

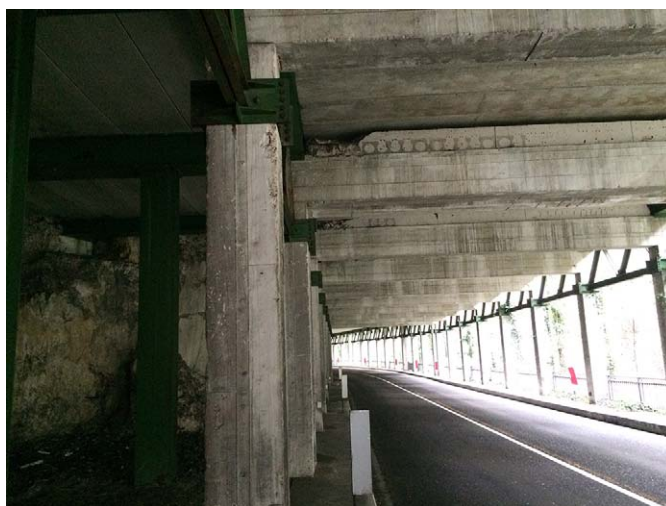
The performance of the rockfall protection tunnel along the *Tre Valli Umbre* highway before the 30 October 2016 event is unknown. As shown in Table 1, PGA values at the site for the three main shocks are 0.11g, 0.07g, and 0.17g for the 24 August 2016, 26 October 2016, and 30 October 2016 events, respectively (PGV values were similarly highest for the 30 October 2016 event). Figure 10 shows an overview of the structural arrangement of the

Figure 10. Overview of the composite steel–RC rockfall protection tunnel near Norcia.

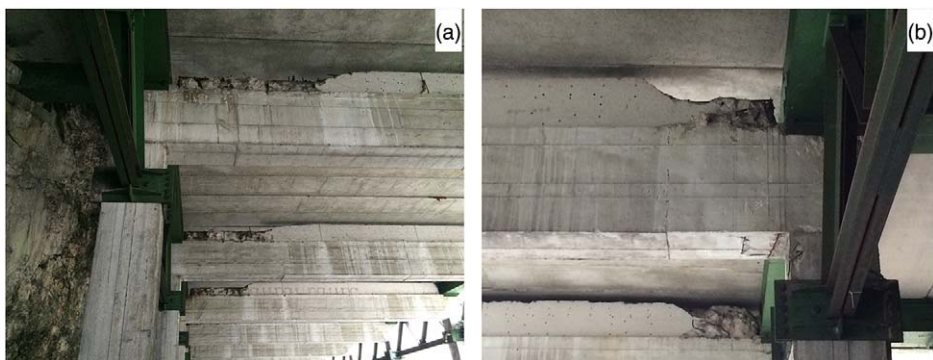
Figure 11. (a, b) Close-up views of reinforced concrete beam-column joint and the steel frame.

rockfall protection tunnel, which consists of a combination of RC columns and RC and steel beam segments. Figure 11 shows details of steel–concrete joints. Prior to the earthquakes, some deterioration and spalling of concrete occurred, which exposed steel rebars (Figure 11a). As shown in Figure 11b, the structure suffered slight damage from pounding. This was evidenced by freshly spalled pieces of concrete.
